## **Phase 2 Addendum No. 1 Remedial Investigation/Feasibility Study Work Plan**

**Weyerhaeuser Company  
Plainwell Mill  
Plainwell, Michigan**

*Operable Unit No. 7 of the Allied Paper, Inc./  
Portage Creek/Kalamazoo River Superfund Site*

**September 2008**

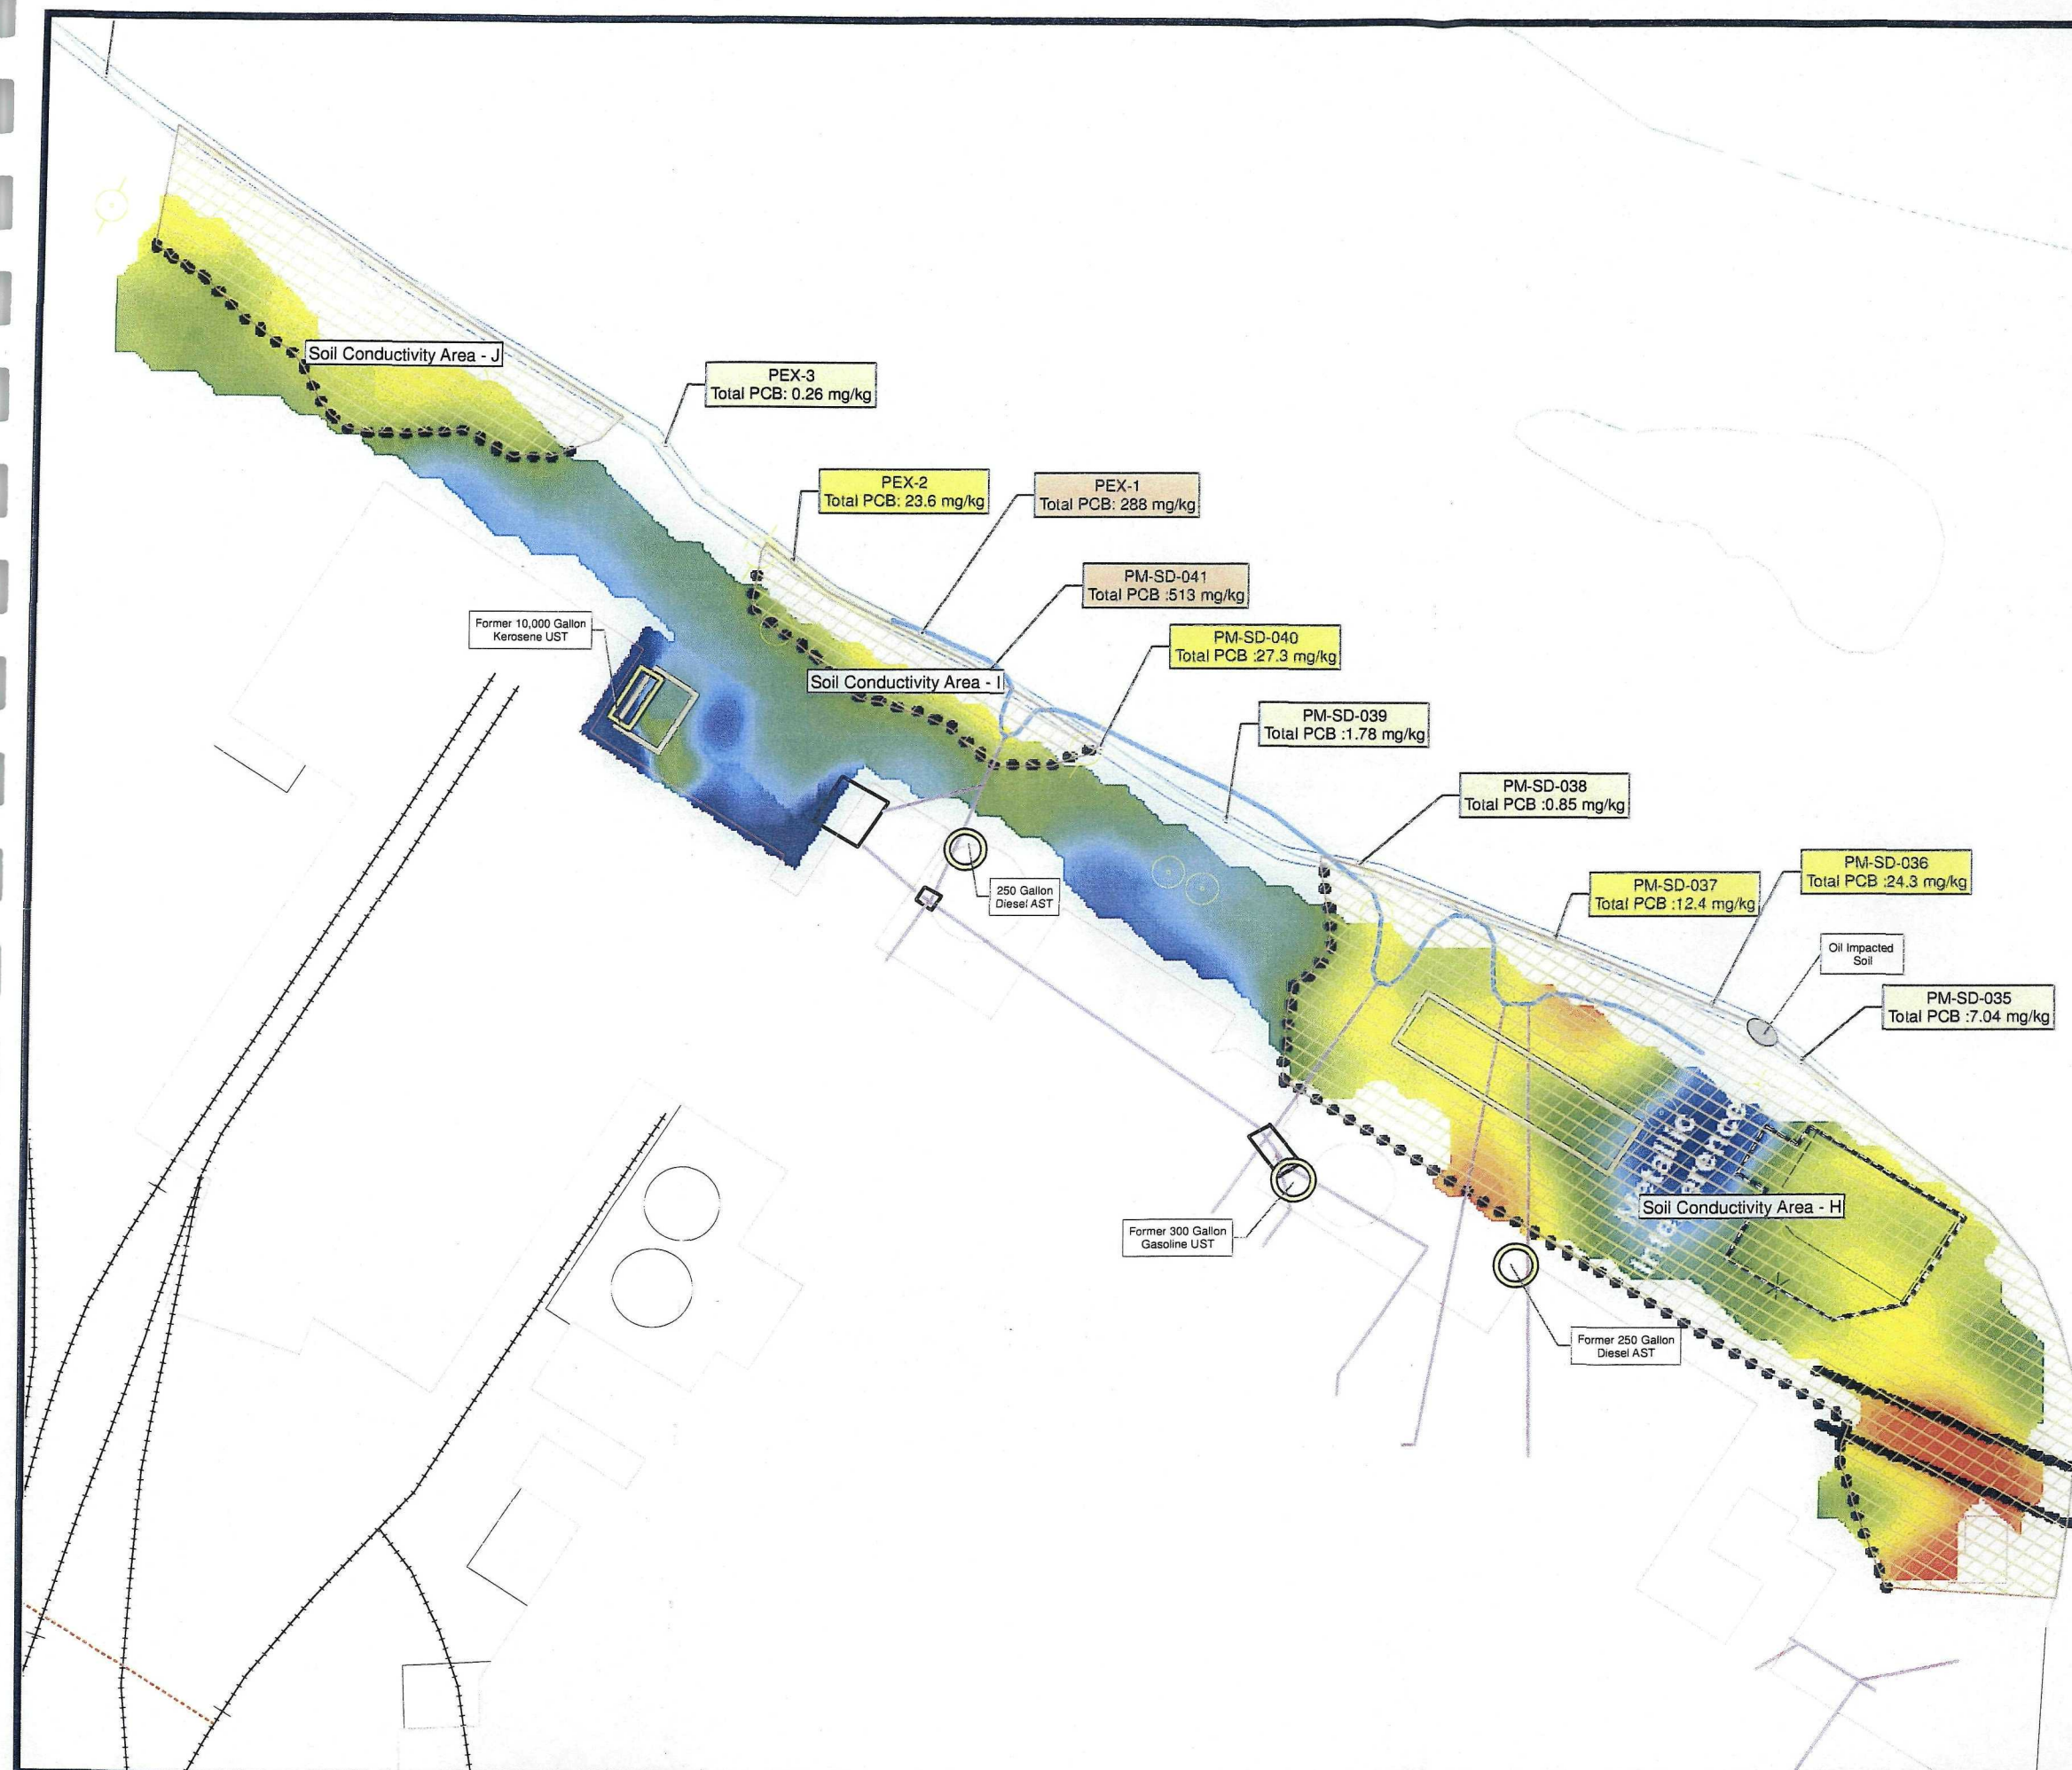
The second geophysical survey performed collected electrical conductivity data. The different electrical conductivity readings provide an indication of different soil types. Typically, less dense materials are less conductive (Red to Yellow) while more dense materials are more conductive (Blue to Green). Due to the native geologic conditions present in Plainwell, the presence of less conductive soils suggests the potential for less compacted fill materials in contrast to the more conductive and undisturbed native soils. Figure 4 and Figure 5 show the soil conductivity maps for the shallow and deep soil depths, respectively.

The shallow and deep conductivity maps display similar features but at different intensities, suggesting that different fill may exist at different depths. Table 4 provides an interpretation of the different soil conductivities observed during the survey. Both the shallow and deep survey show three low conductivity areas (Soil Conductivity Areas H to J); two narrow bands along the river in front of the Mill buildings and essentially the entire eastern portion near the Mill Race. These low conductivity areas as previously indicated are likely composed of some type of coarse fill material. The location of the some fill areas appears to correlate with the elevated PCB concentrations found during the Plainwell Mill Banks Emergency Action (Areas I and J). The areas of higher conductivity near the Mill buildings are likely composed of naturally dense or manually compacted soils.

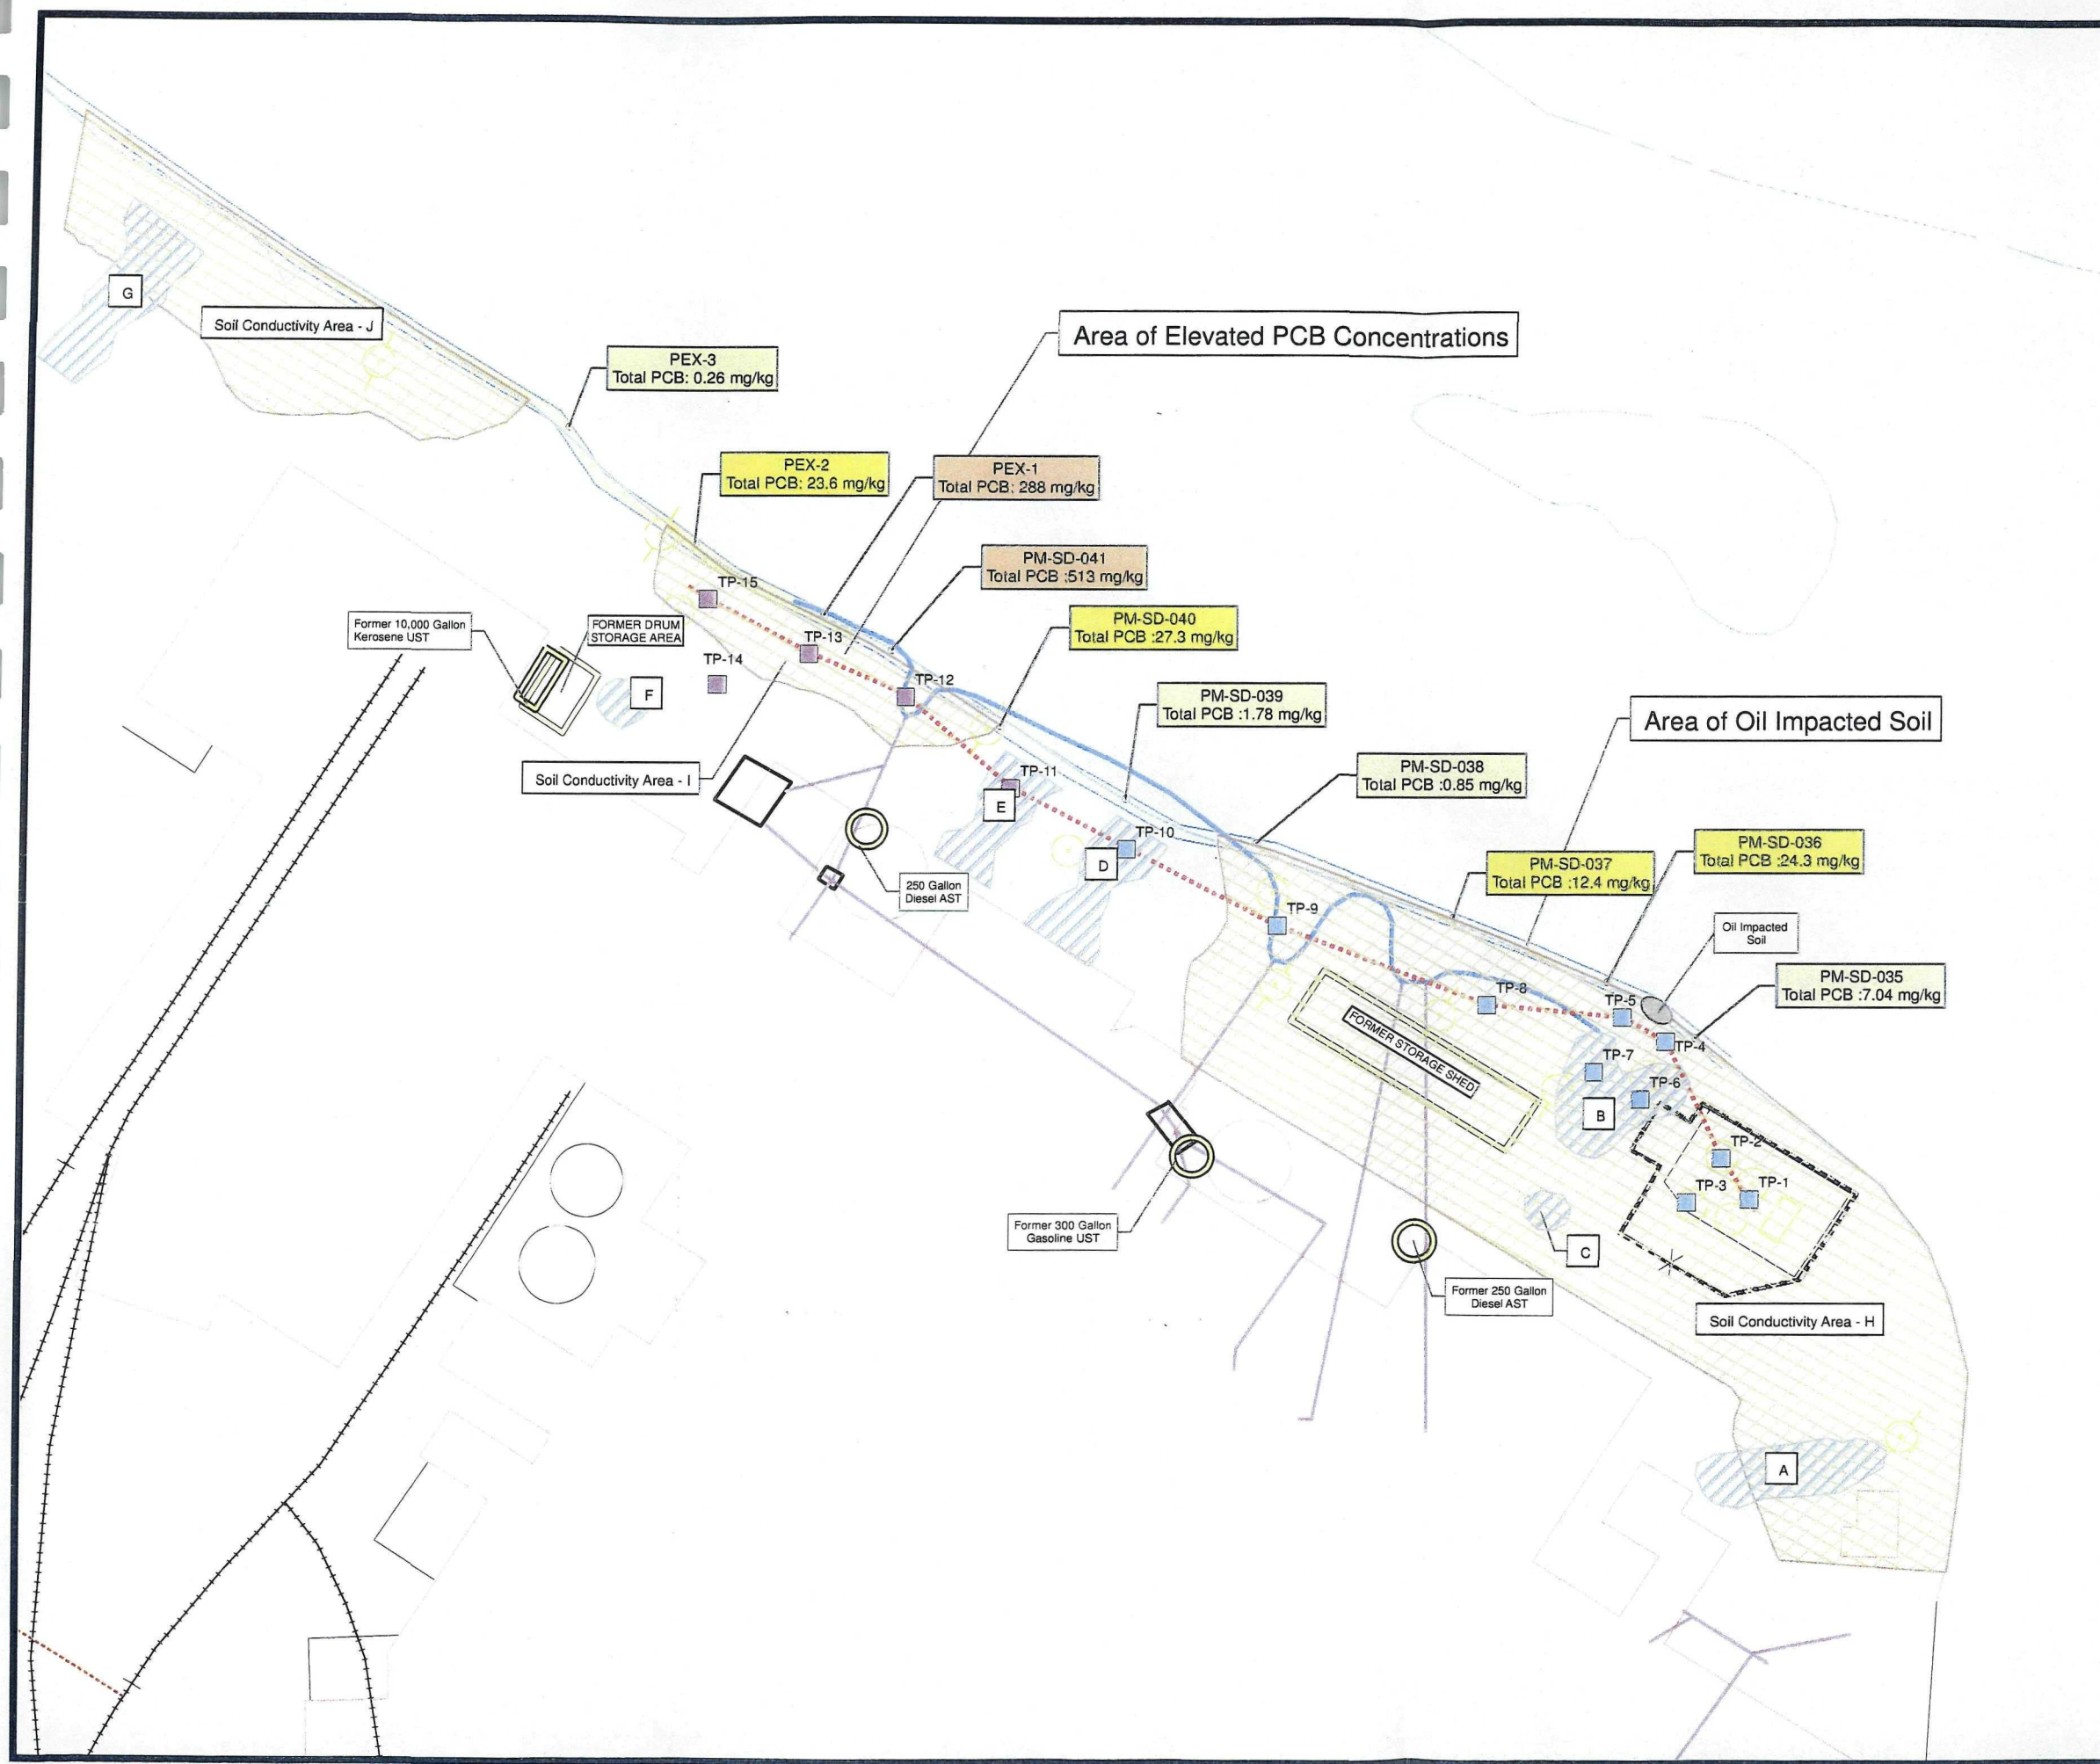
1. All test pit locations are approximate and may change depending upon site conditions.
2. Test pit locations near the former transformer station will be refined after receipt of information from Consumers Power.
3. "Soil Conductivity Areas" refers to areas of less dense soils detected during the soil conductivity survey.

Specific Question or Concern	Rationale	Specific Test Pits that Will Address Concern	
USEPA Concerns Identified in February 19, 2008, Letter	1. The cause of the oil sheen and whether free NAPL is the cause.	Test pits will be used to identify the source of the oil impacted soil and extent. In addition, test pits will be used to inspect Metallic Object B detected in the vicinity of the oil impacted soil.	Four Test Pits: TP-4 through TP-8

2. Whether the NAPL is the cause of the high PCB concentrations observed.	Tests pits will be advanced at eleven locations along the bank to determine if the two areas of concerns are related or connected.	Eleven Test Pits: TP-1 through TP-15 along the Red Dashed Line following the River Bank

3. Whether NAPL, if present, could be entering the Kalamazoo River.	Observations of site conditions during installation of test pits will determine if NAPL is present, and if so, does it have the potential to enter the river. Test pits will be used to identify the presence of free product or oil saturated soil. (The bank along the Plainwell Mill buildings was sealed with clay and armored to prevent any ongoing releases (Appendix B). In addition, various site visits have not documented any ongoing NAPL releases.	Eleven Test Pits: TP-1 through TP-15 along the Red Dashed Line following the River Bank
Uncertainties with Site Conceptual Model and Other Concerns	4. Are the elevated PCB concentrations associated with the suspected fill material near Soil Conductivity Area I?	Test pits will be advanced within and outside this area to determine subsurface conditions and their relationship between PCB concentrations and the geophysical survey.	Five Test Pits: TP-11 through TP-15

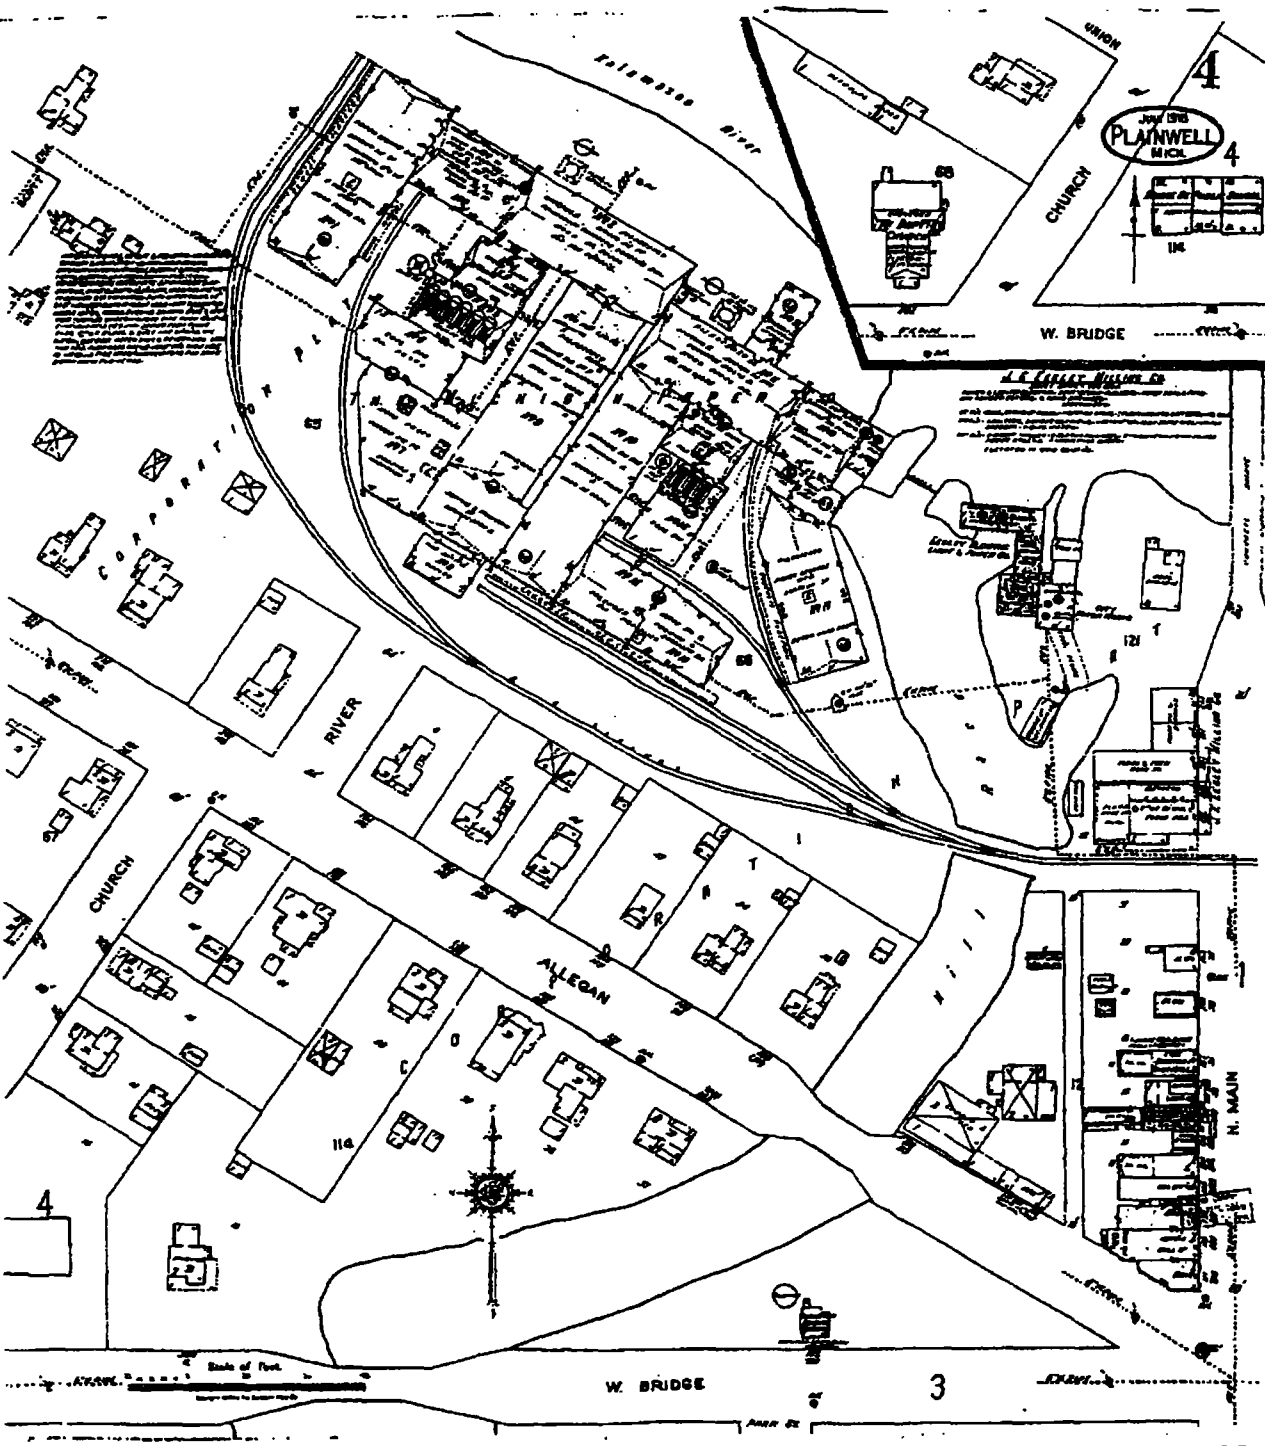
Small Structure

In addition, the Sanborn map from 1928 is the first map to include the clear outline of a small structure located adjacent to the river bank in front of the Mill buildings. The structure is still present in the 1950 Sanborn map, which is the last map available for review on this site.

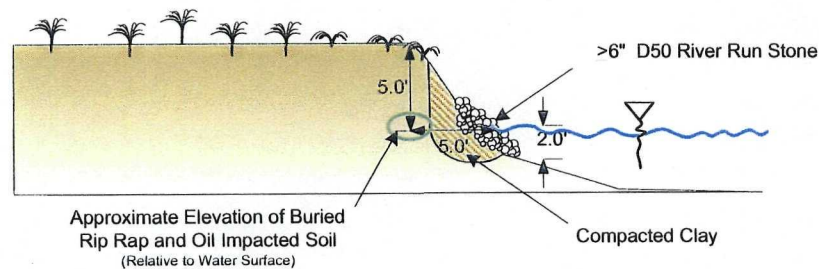
## 3. ZONE D AFTER CLAY PLACEMENT AND ARMORING

1. A USCS classification of SC, CH, CL/ML, or ML
2. A saturated hydraulic conductivity of  $1 \times 10^{-7}$  cm/s or less, when compacted to 90% Modified or 95% Standard Proctor Density

Due to site conditions requiring placement of clay into the saturated zone, typical compaction of the material was not possible. Therefore, the clay was compacted in place using the mechanical excavator immediately after placement.

The design specified a stone (D50 of  $\geq 6$  inches) rip rap along the entire shoreline. Riprap with a D30 of 2 inches will withstand the erosive forces produced along the shoreline at a velocity of 5-6 fps. The larger stone size was specified to address the potential greater stresses on the riprap caused by ice and debris. The river run stone was placed from an elevation approximately 2 feet below river level to 2 feet above the river/bank interface. Details are shown on the attached Figure B-1.

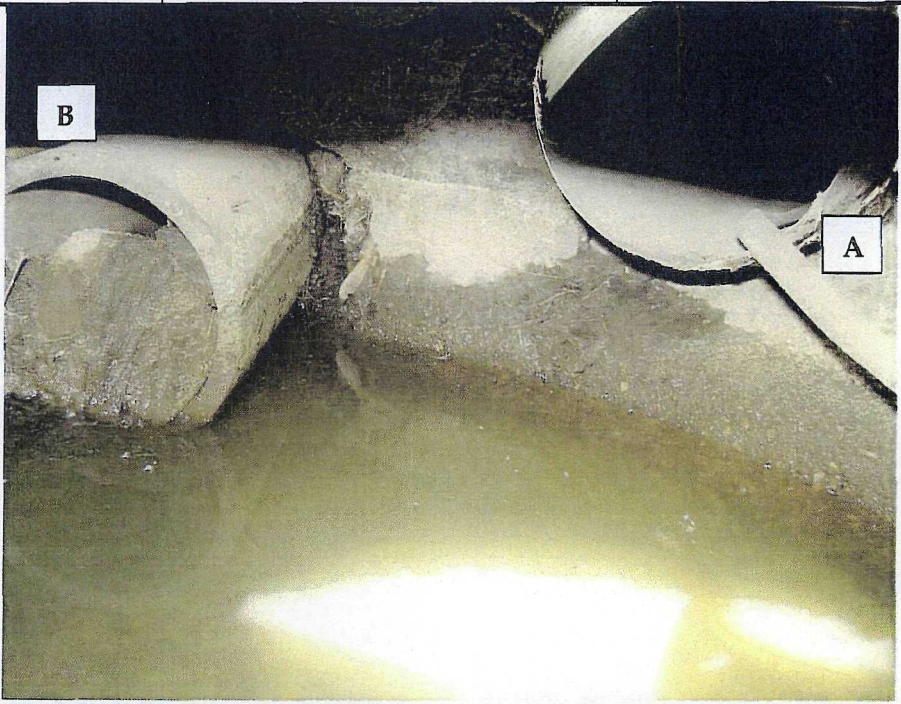
Photo No. 1	Date 5/29/08

<b>Description</b> Photograph viewing inside the manhole looking towards the southwest.

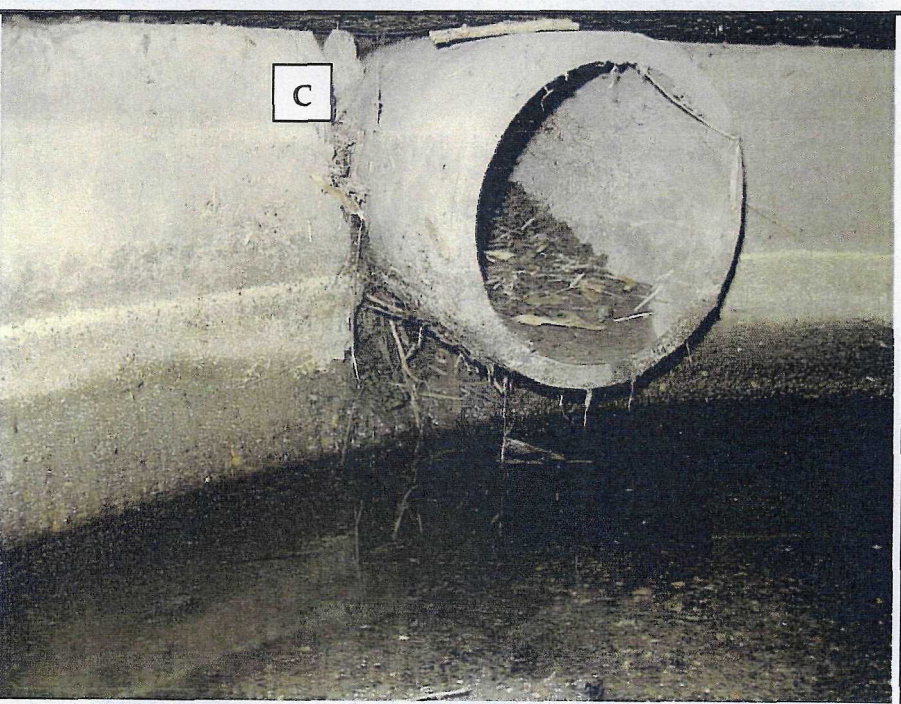
Photo No. 2	Date 5/29/08

<b>Description</b> Photograph viewing inside the manhole looking towards the southeast.
